# Ultraviolet Imaging Techniques for Off-Line Condition Monitoring of Power System Equipment

*Khawla Saeed Salim Al-Khawaldi*  
*Ohood Khamis Suwaid Al-Maqbali*  
*Fatema Khamis Rashid Al-Maamari*  
*Bashayar Saif Said Al Khawaldi*  
*Murali Krishna Boddu*

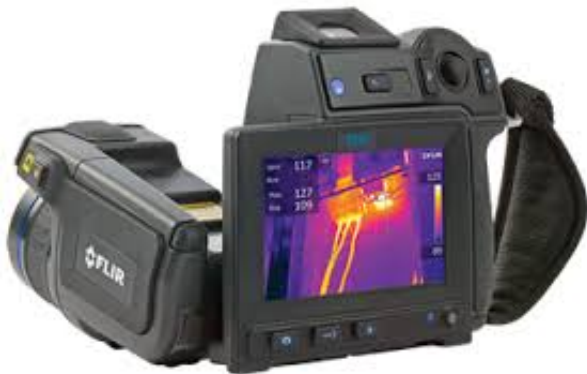
**Figure 2.** Thermal Imaging Camera (FLIR).

The UV and IR detection of Power System Equipment faults can be done at a local 33KV/11KV primary distribution substation. The equipment selected for the taking images are IR camera and UV imaging Camera. These two devices can take the image of the equipment where human naked eye can not detect the fault caused by both temperature and corona.

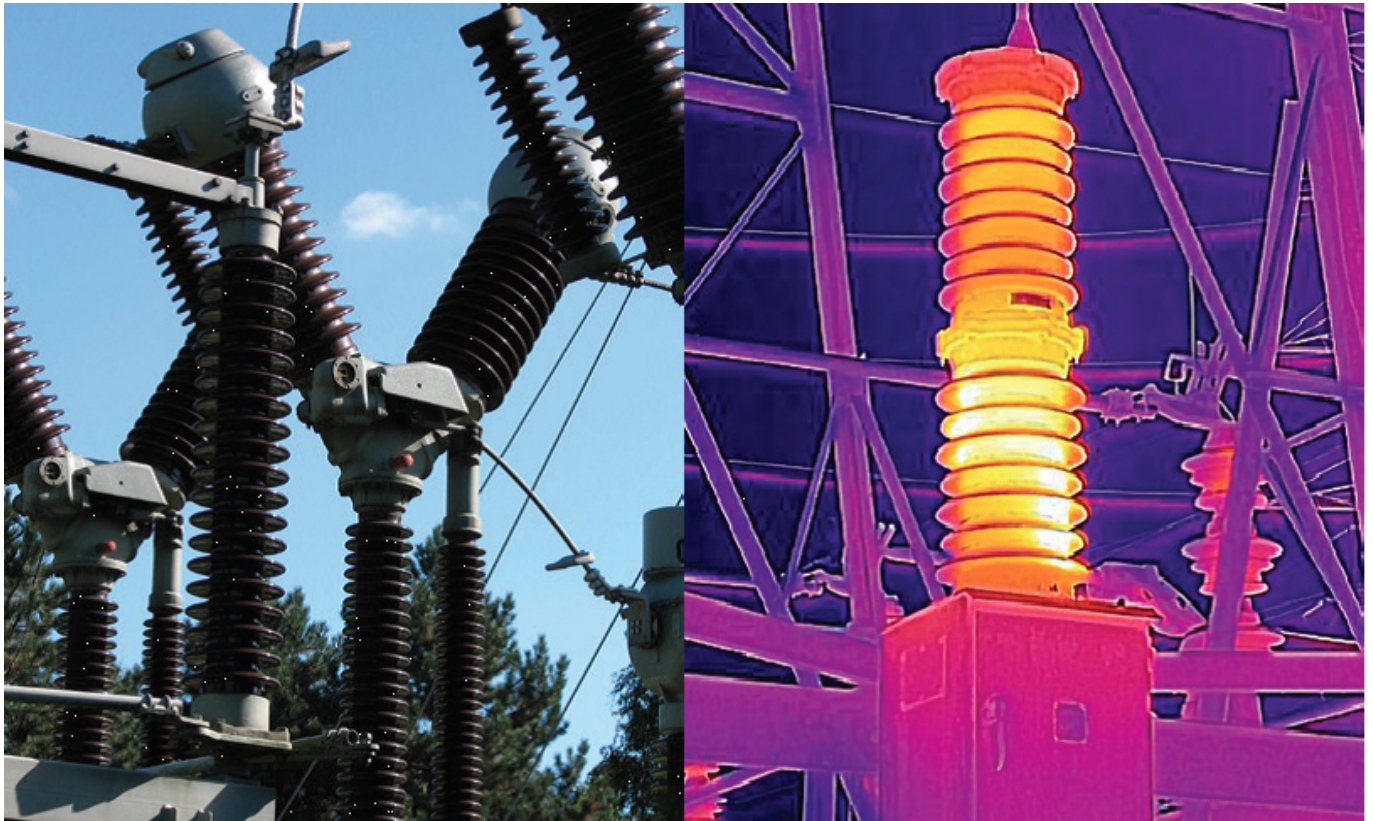
**Figure 4.** *Insulator inspections using IR camera.*

When an insulator fails, it may cause a widespread outage, creating a larger, more unmanageable problem. Insulators located up high and out of reach. Since it's difficult to inspect, it's also a challenge to diagnose a problem, the failing component could be inside of the insulator, making it harder to get an accurate temperature measurement from a distance.

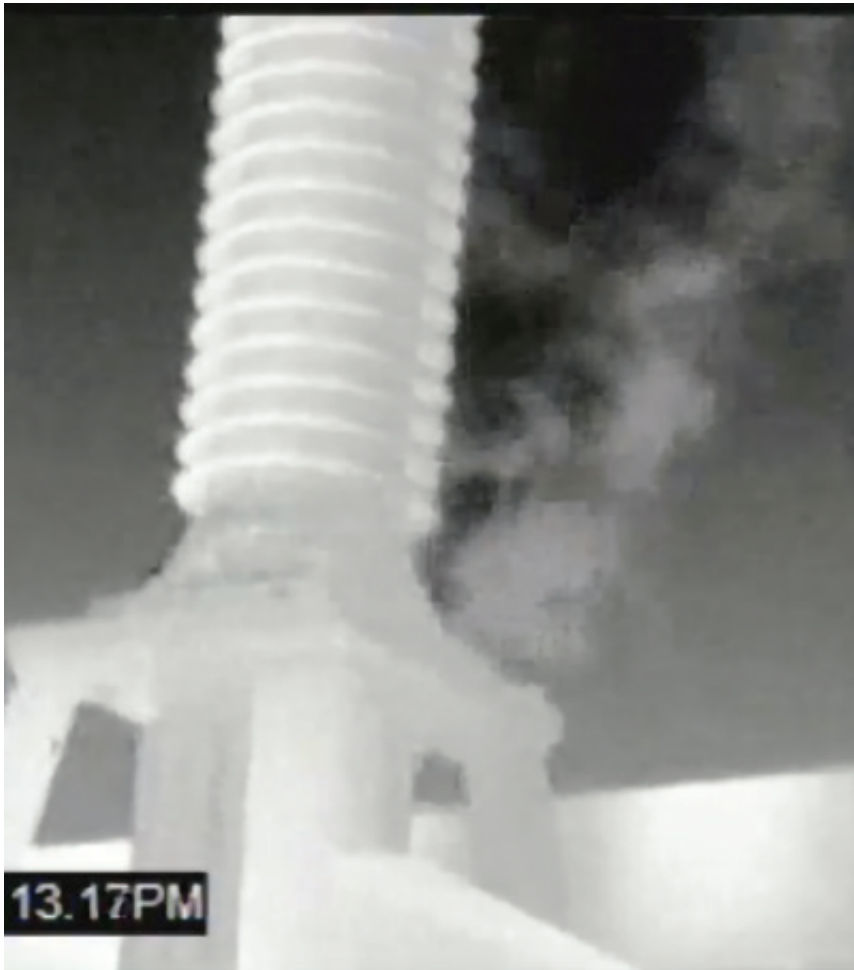
**Figure 5.** *SF6 Circuit Breakers using IR camera*

There's a gas leak in a SF6 breaker, it's crucial to locate and fix it immediately to minimize downtime and revenue loss. It's not always possible to come into close contact with the breaker to inspect it. The longer a leak is left unrepaired, the more revenue lost, and the greater the carbon footprint on the environment.

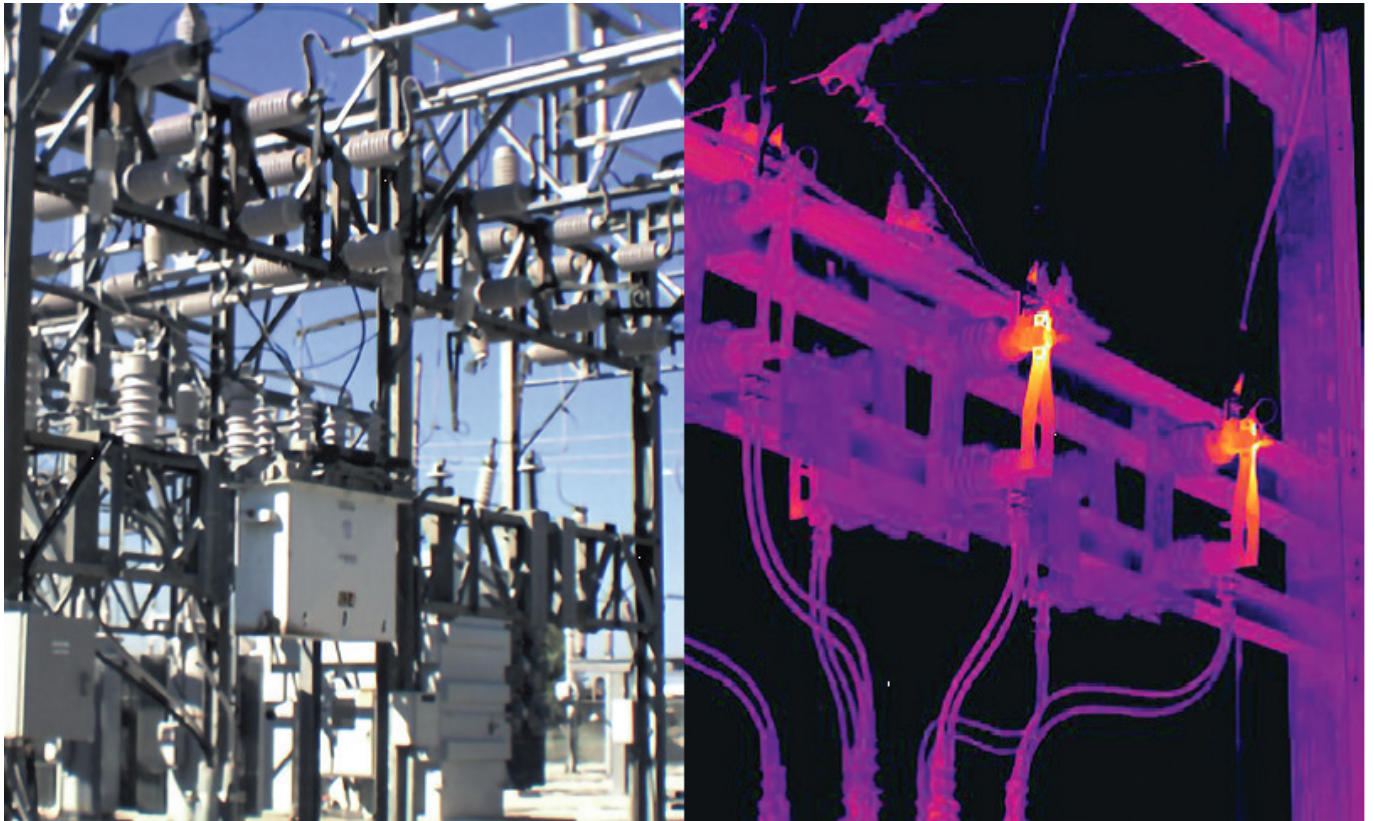
**Figure 6.** *Connections in Transmission using IR camera*

If an electrical connection isn't working properly, system may not operate efficiently or safely. It's important to regularly inspect every connection to ensure that they are in working order, but this can be a challenge. Every system has a lot of small connections, and they are often located high up out of reach.

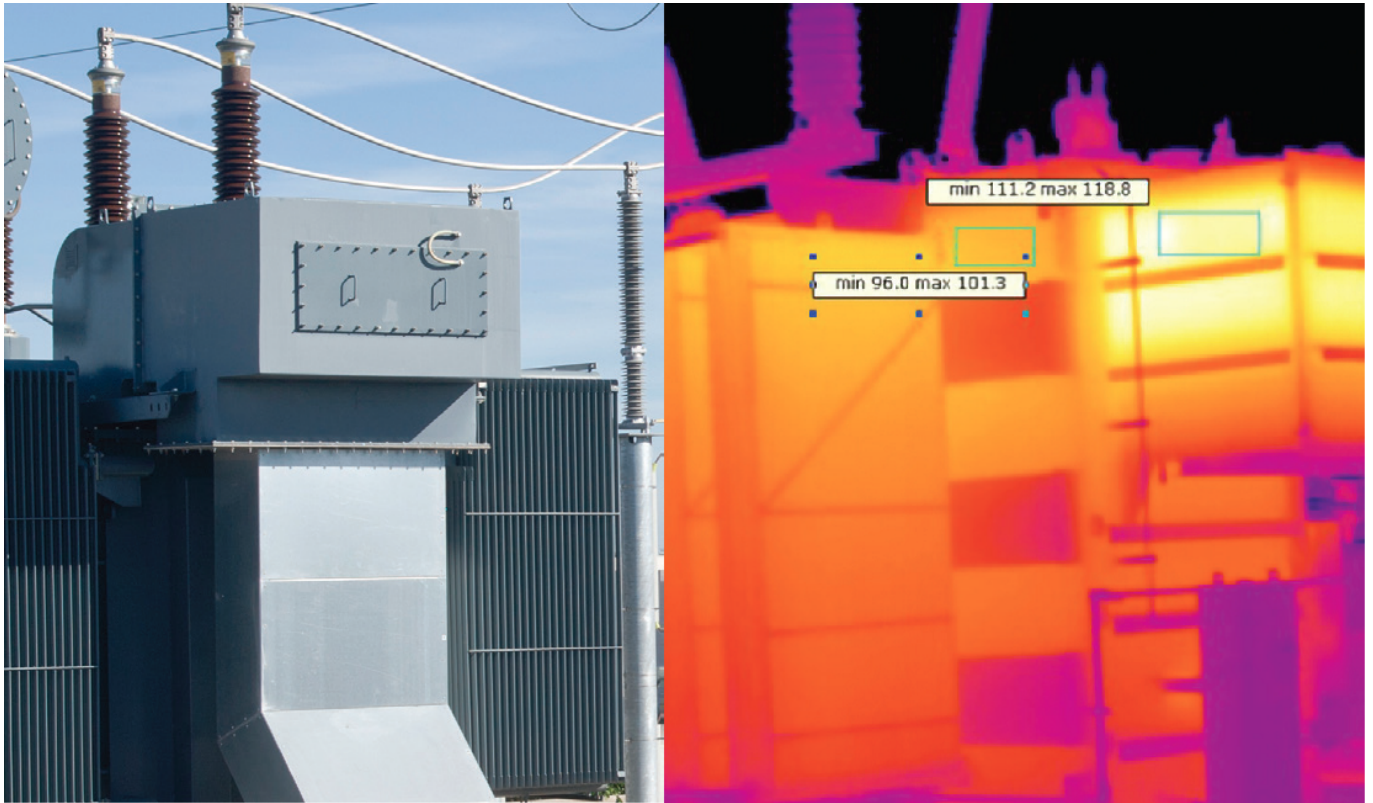
**Figure 7.** LTC inspections using IR camera.

If an LTC fails, the entire transformer will shut down. It causes additional expenses to expedite repair. This outage will adversely affect numerous distribution circuits and the remaining power grid due to the need to reroute the load to supply the affected circuits. Regularly assessing the health of LTCs and catching problems before a failure occurs is important to prevent downtime and minimize the cost of repairs.

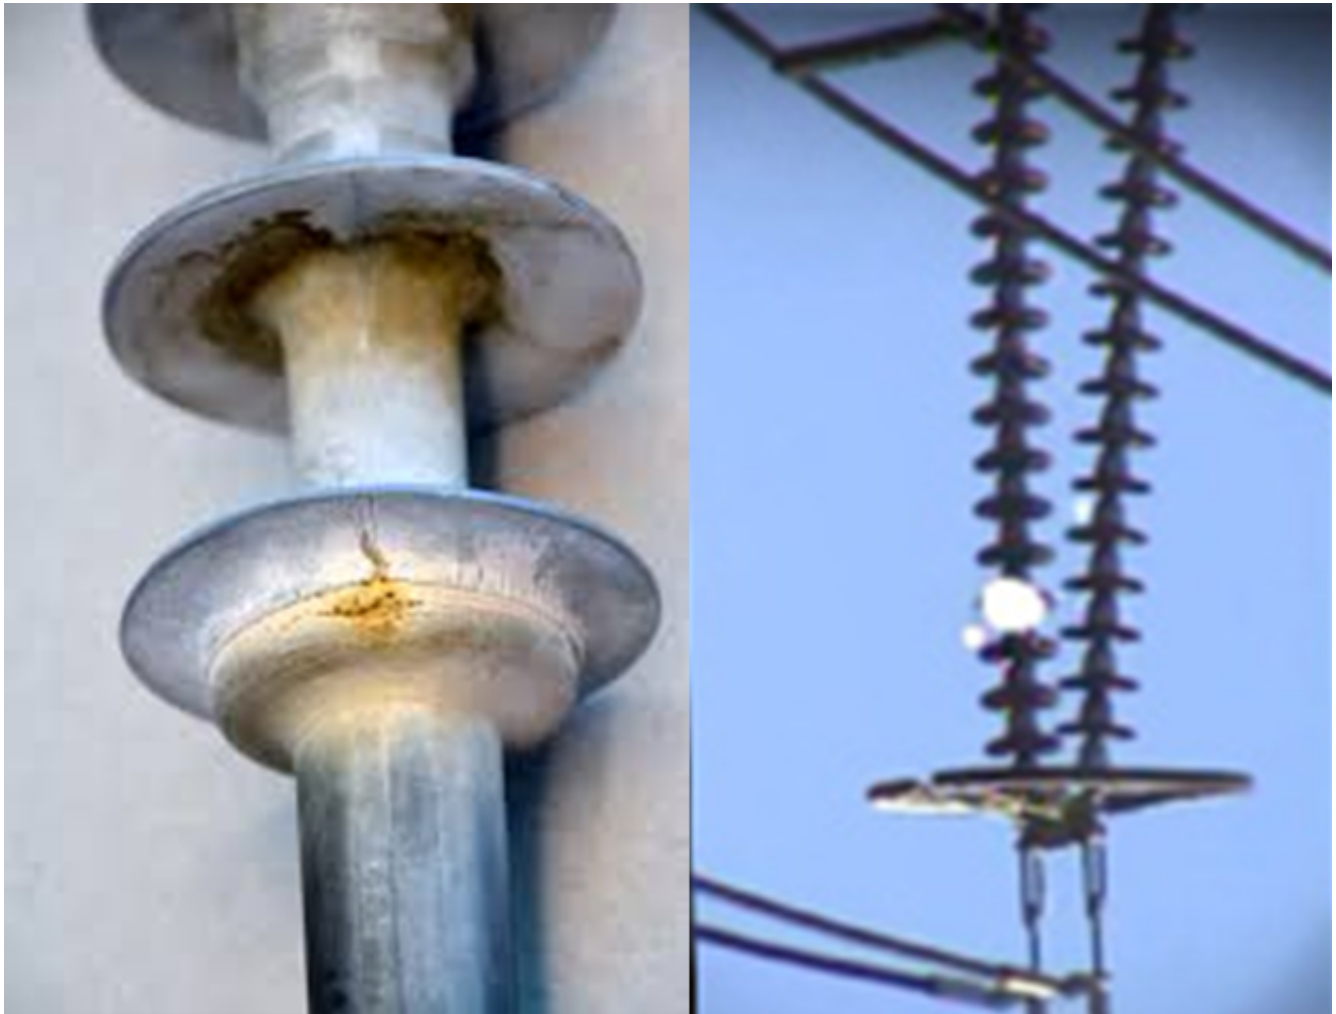
**Figure 8.** *Degradation Insulators using corona camera.*

There is a slow but progressive degradation of the polymeric insulator cover compound. This is due to open-atmosphere aging, where UV radiations from sunlight and electrical discharge adversely affect the matrix polymer. Other factors such as sandstorm, acid rain, and bird pecking.

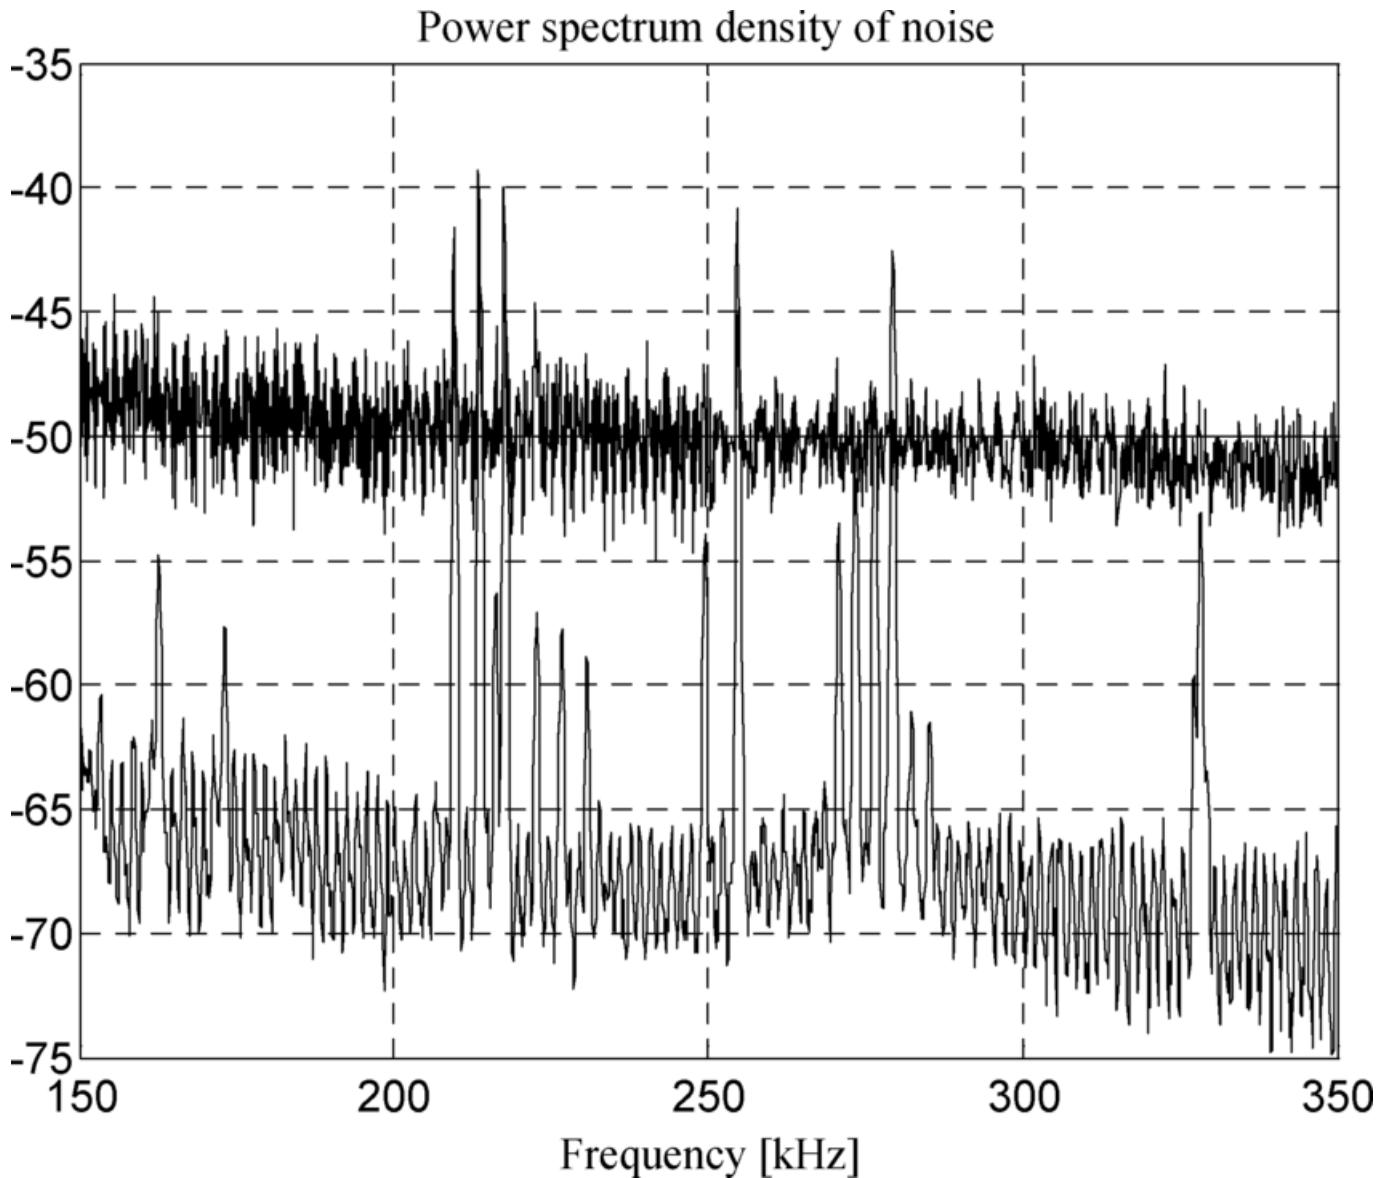
**Figure 9.** *Communication Interference.*

Power-line noise can interfere with radio communications and broadcasting. Essentially, the powerlines or associated hardware improperly generate unwanted radio signals that override or compete with desired radio signals.

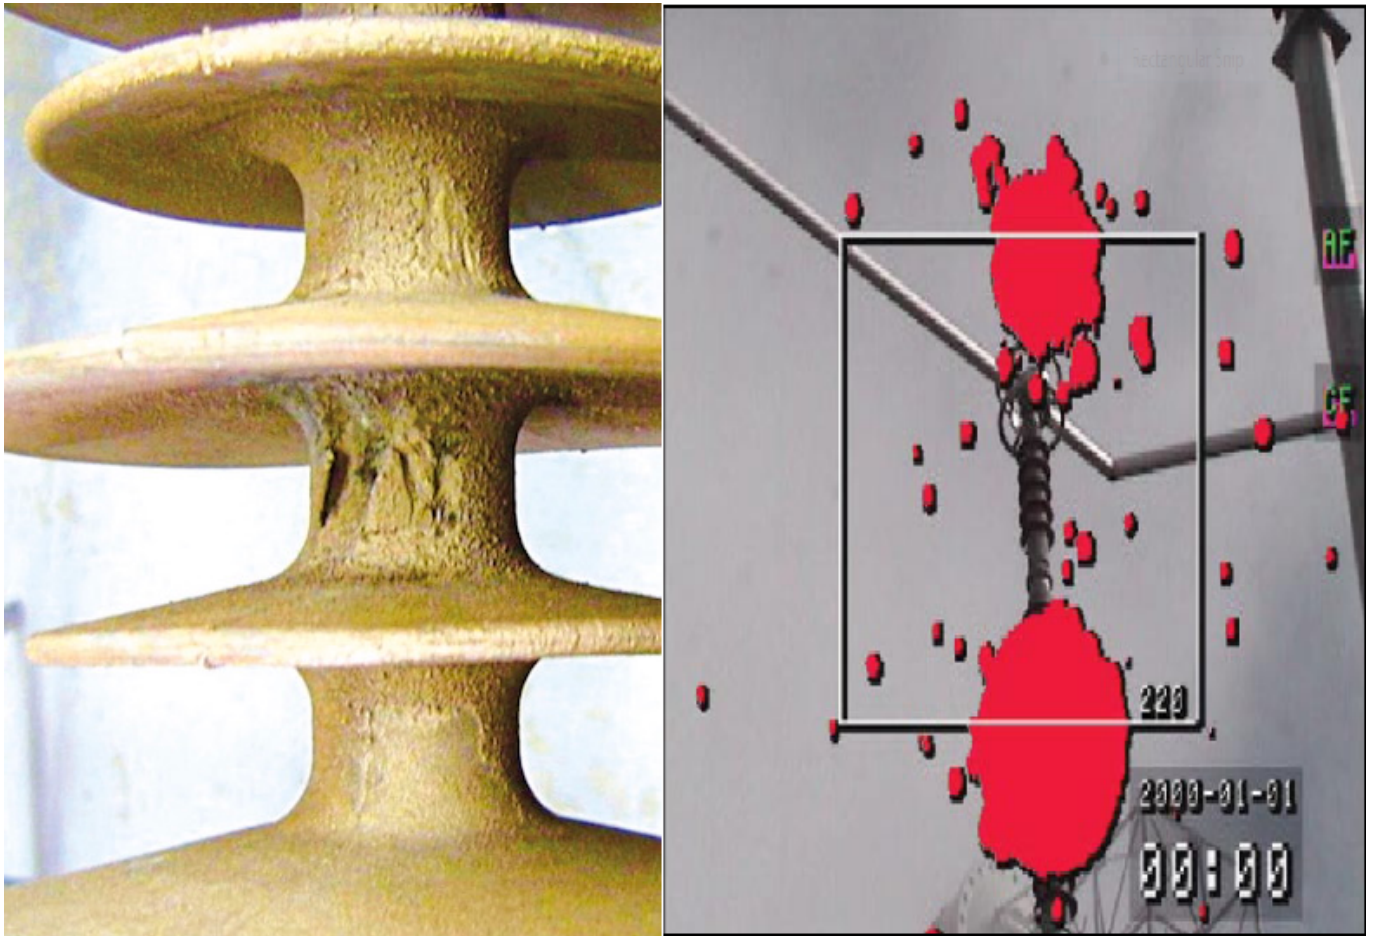
**Figure 10.** *Improper installation of Insulator.*

Electrical design of composite insulators should not be made looking solely at flashover performance during short-term tests. Rather, it must be based on risk of surface degradation from partial discharges which, over the long term can lead to tracking, erosion and eventual failure. Indeed, this is critical since composite insulators are vulnerable to damage should there be continuous partial discharges and arcing activity on or near their surfaces.

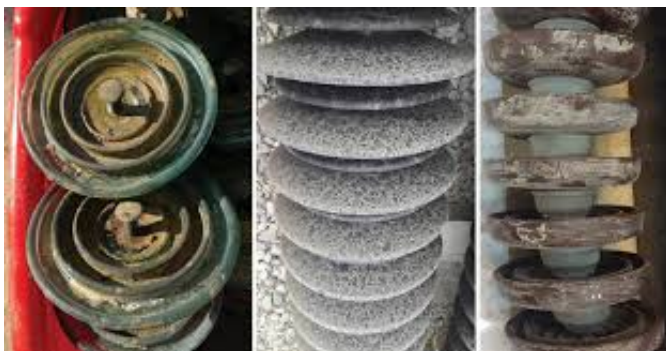
**Figure 11.** *Cracked porcelain Insulators.*

Porcelain bushings should be regularly checked for [cracks and/or contamination](#). If the bushing is damaged or heavily contaminated, leakage current will become excessive, sometimes appearing as carbon tracking, or "treeing", on the bushing surface. Flashovers may occur if the bushings are not cleaned periodically.

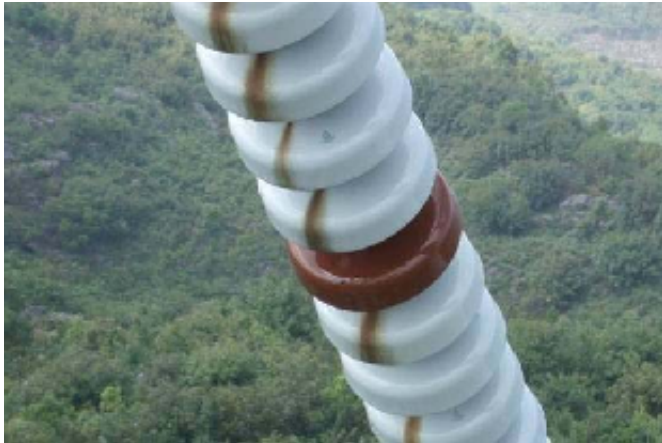
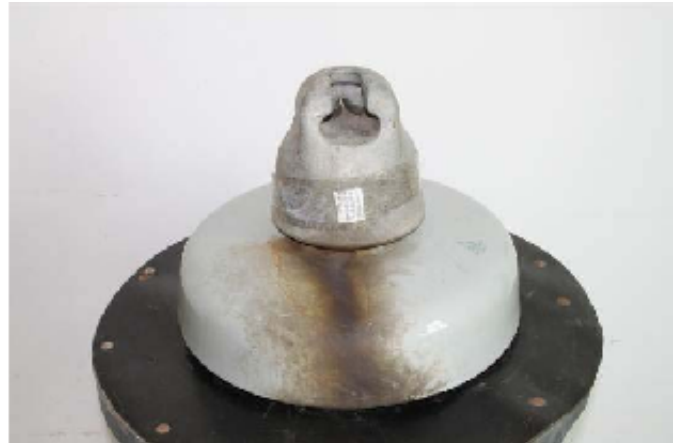
**Figure 12. Rust on Caps and Pins of an Insulators.**

Phenomena linked to corrosion of metal parts to affect the electrical resistance due to the formation of a deposit of rust on the insulating surface. To cause the breakage of the dielectric due

to the expansion of the pin corroded. This phenomenon is specific for porcelain cap and pin insulators.

a Corroded V-string insulators      b Rust on the insulator surface  
**Figure 1. Corrosion of insulators' iron cans.**
